Test Report

Sample(s) Name	LED Honeycomb Module
Item No.	HC-200
Brand

Results:**Neutral Salt Spray Test**

Test method: ASTM B117-2011

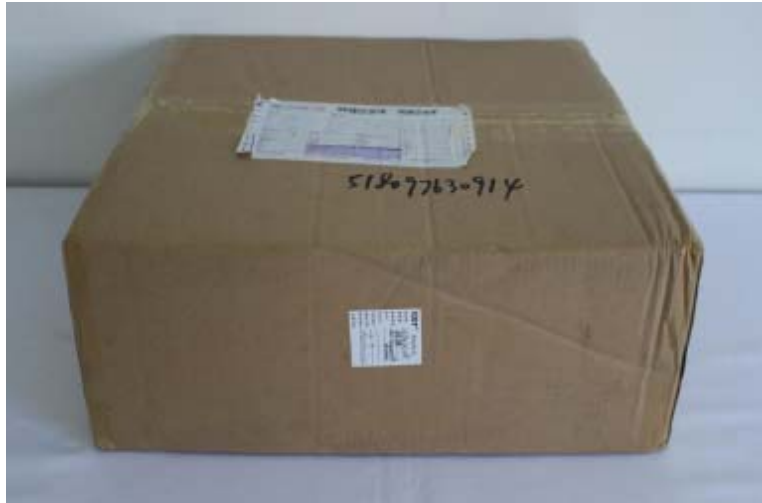
Photograph(s) of Sample

No.	Sample(s) name
1	LED Honeycomb Module

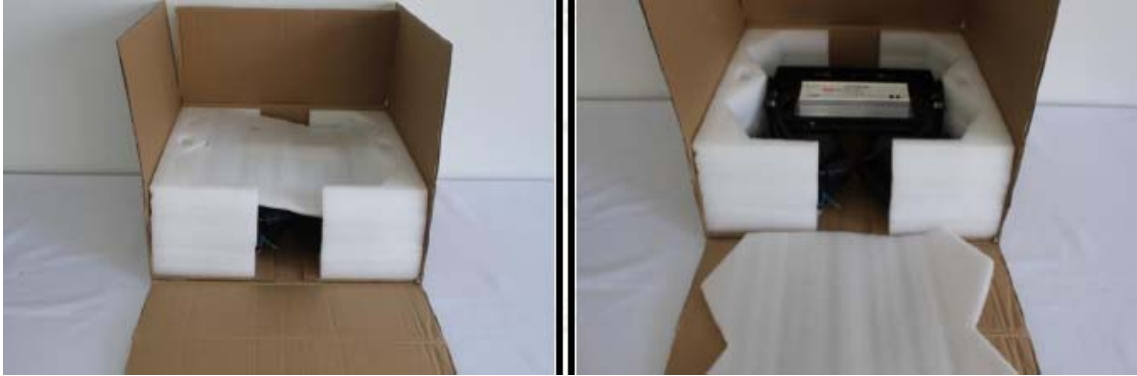
Fig 1 Vibration Test

Fig 2 Vibration Test

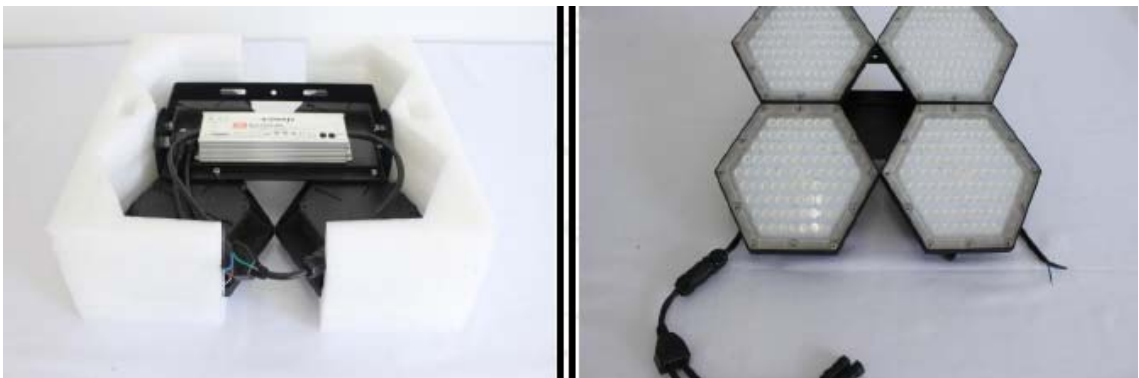
Fig 3 Vibration Test

Fig 4 Vibration Test

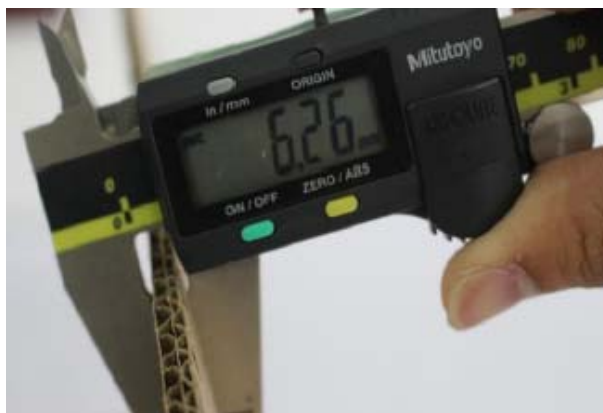
Fig 5 Vibration Test
